# Repairing & Maintenance of Building

**Engr. M A Wahed**

HBRI

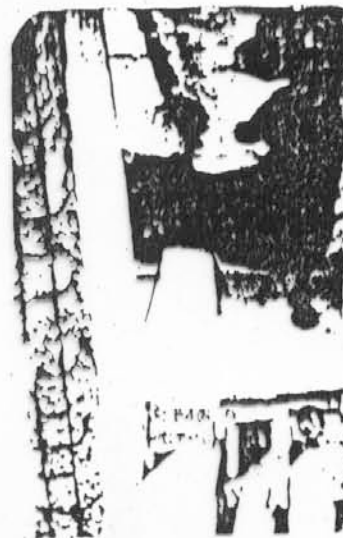
*Photo 4. Spalling of concrete in column and slab*

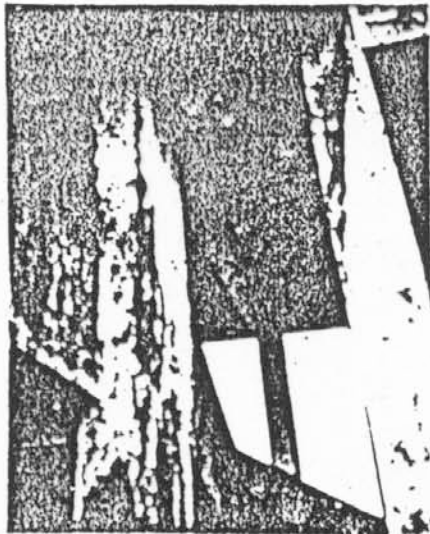
*Photo 5. Cracks in columns*

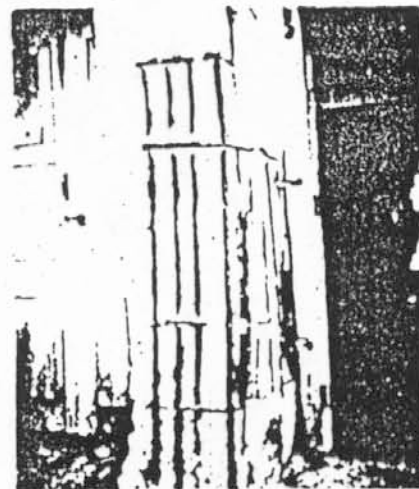
*Photo 6. Spalling of concrete in column*
